RE: Request for Information (“RFI”) Pursuant to Section 308 of the Clean Water Act  
Compliance Evaluation Inspection Report (“CEI”) conducted on April 4, 2016  
ACE Auto Parts Inc.  
Docket No. CWA-IR-17-005

**COMPLIANCE EVALUATION INSPECTION REPORT**

<b>Compliance Evaluation Inspection:</b> ACE Auto Parts, Inc.	
<b>Inspection Date:</b> April 4, 2016	<b>Inspection Time:</b> 11:30AM – 1:15PM
<b>EPA Inspector:</b> Cyndy S. Kopitsky, Environmental Scientist, USEPA Region 2, DECA, Water Compliance Branch (212) 637-3832 & Andrew Dinsmore, Stormwater Team Leader USEPA Region 3 (215) 814-2788	
<b>NJDEP Representative:</b> Sandy Crowley, 609-439-9537	
<b>On-Site Representative:</b> Domenic Monarco, 856-365-4778/ 609-634-4383	
<b>Site Information:</b> ACE Auto Parts, Inc. 1999 Cooper Street Camden, New Jersey 08105  <b>Owner/Operator/Permittee:</b> ACE Auto Parts, Inc. 1999 Cooper Street Camden, New Jersey 08105  SPDES No. NJG0141984

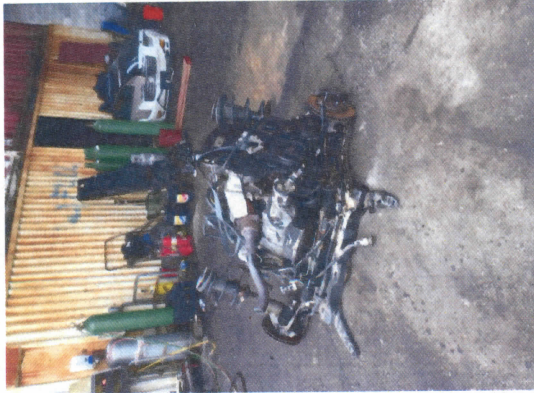
IMG\_2928

2. At the time of the inspection, EPA noted engines, motor parts, and scrap materials on the ground of the facility and uncontained as seen in photos IMG\_2928, IMG\_2930, IMG\_2955, IMG\_2932, IMG\_2955..

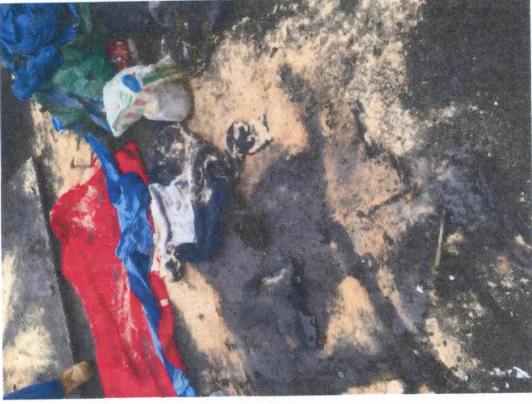
IMG\_2929

At the time of the inspection there was various locations where oil had spilled/leaked and speedy-dry absorbent materials spread on the ground as seen in photos IMG\_2929, IMG\_2930, IMG\_2936, IMG\_2938, IMG\_2939, IMG\_2940, IMG\_2946, and IMG\_2962. At the time of the inspection there were no spill kits on site.

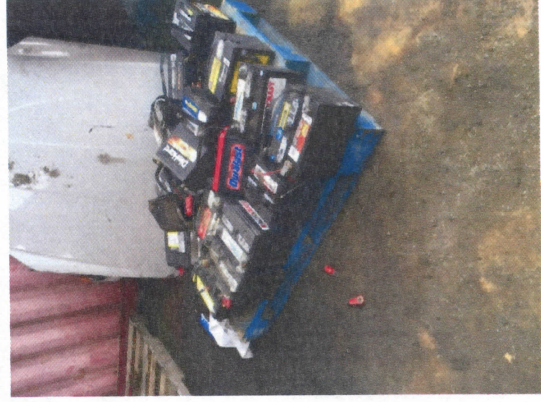
During the walkthrough, the EPA inspectors observed a pile of batteries stored outside located in the SE area of the facility as seen in picture IMG\_2931.

3. At the time of the inspection, batteries were uncovered and piled on a wood pallet and cylinders were piled on the ground and exposed to stormwater as seen in photos IMG\_2931 and IMG\_2946.

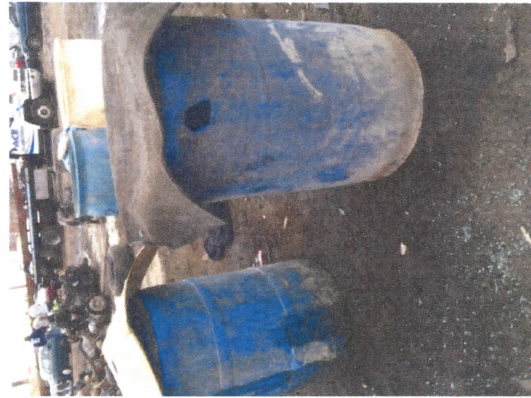
IMG\_2944

During the walkthrough EPA observed various unmarked fluid containing drums and containers and several covered with a rug/remnant material as seen in photos IMG\_2944, IMG\_2948, IMG\_2950, and IMG\_2952.

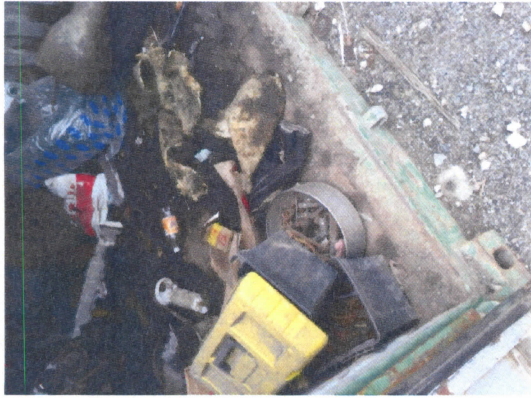
IMG\_2954

At the time of the inspection, EPA noted trash and scrap materials on the ground and uncontained as seen in photos IMG\_2954, IMG\_2955, IMG\_2957, IMG\_2958, IMG\_2959, IMG\_2961.

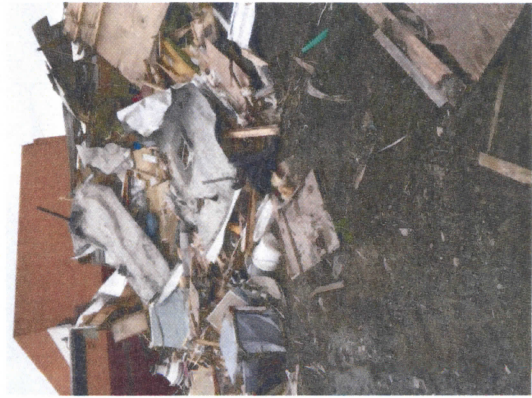
IMG\_2957

1. At the time of the inspection, EPA observed that the empty dumpsters on the site were uncovered and trash piles were surrounding the dumpster as seen in photo\_IMG\_2957.
